TOWNSHIP OF BYRAM LAKES AND WATERSHEDS MANAGEMENT PLAN

TOWNSHIP OF BYRAM, SUSSEX COUNTY, NEW JERSEY

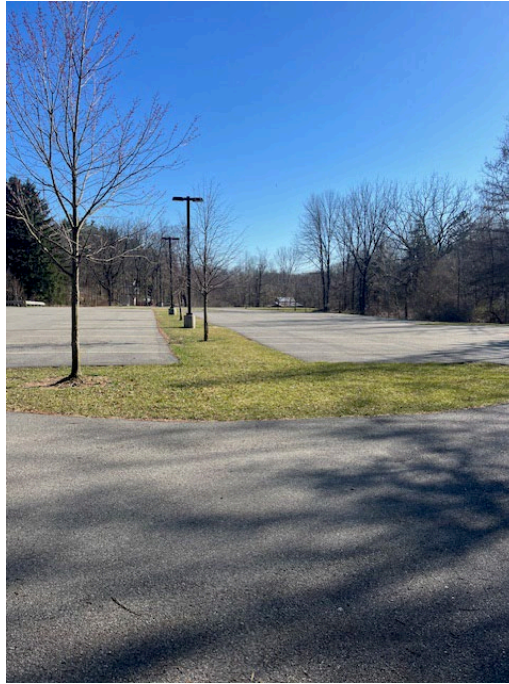
Photo 8-1: The western parking lot at Tamarack Park (Recommendation 1A)

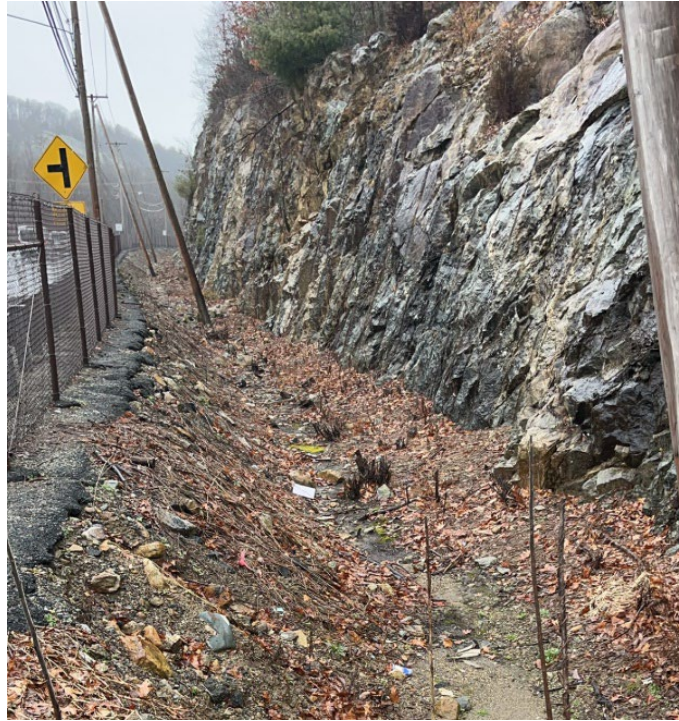
Photo 8-2: Swale that runs alongside Route 206 N (Recommendation 2A)

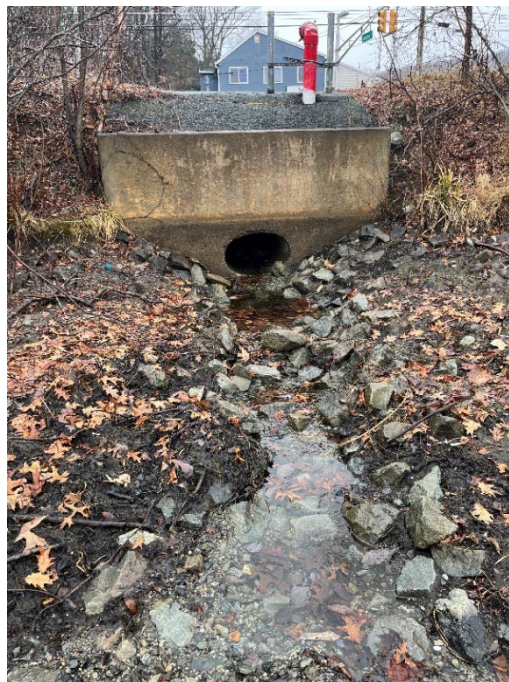
*Photo 8-3: The drainage from the swale across Route 206
(Recommendation 2B)*

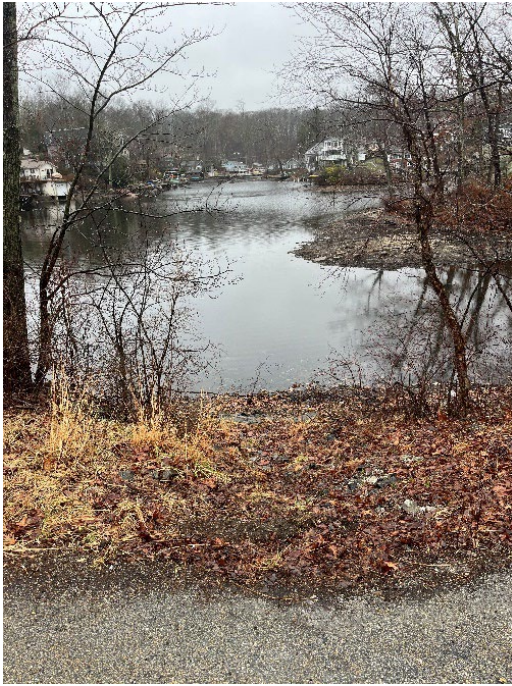
*Photo 8-5: An example of the rills created along the parking lot draining directly into the lake
(Recommendation 3A)*

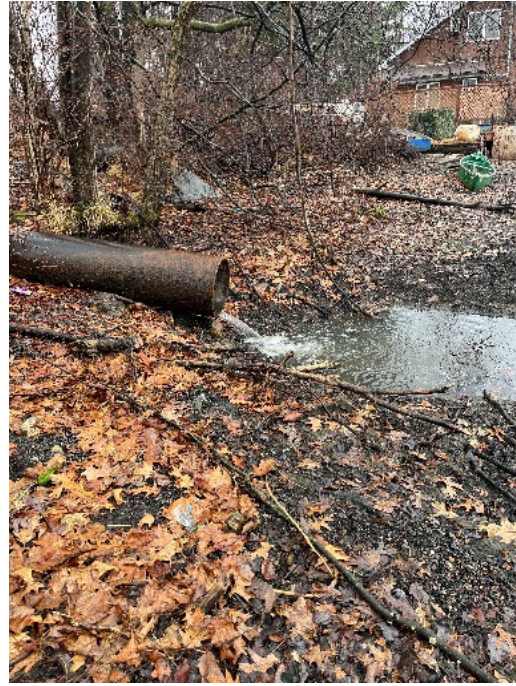
*Photo 8-4: A drainage pipe from a Route 206 storm drain into Cranberry Lake
(Recommendation 3D)*

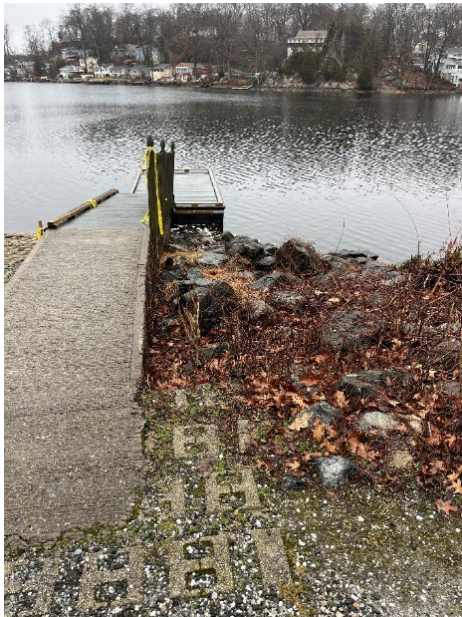
Photo 8-6: North side of the Cranberry Lake boat ramp (Recommendation 4A)

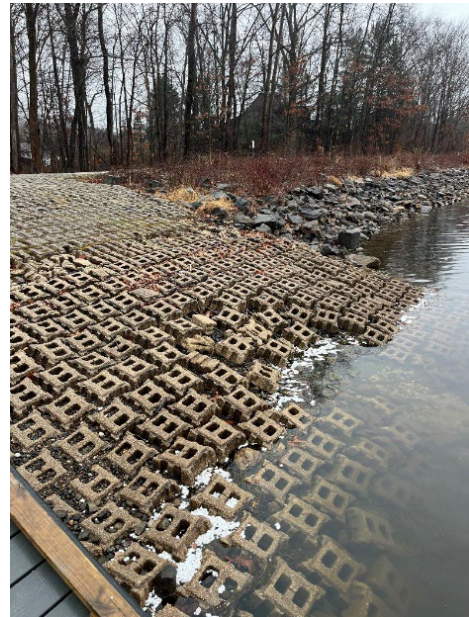
Photo 8-7: Cranberry Lake boat ramp (Recommendation 4A)

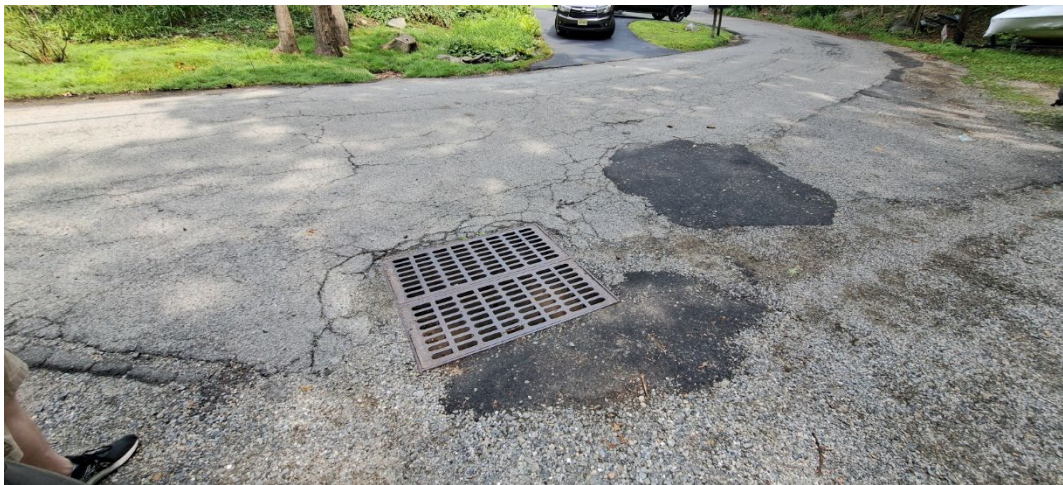
Photo 8-11: Standard catch basin along Cabin Spring Trail

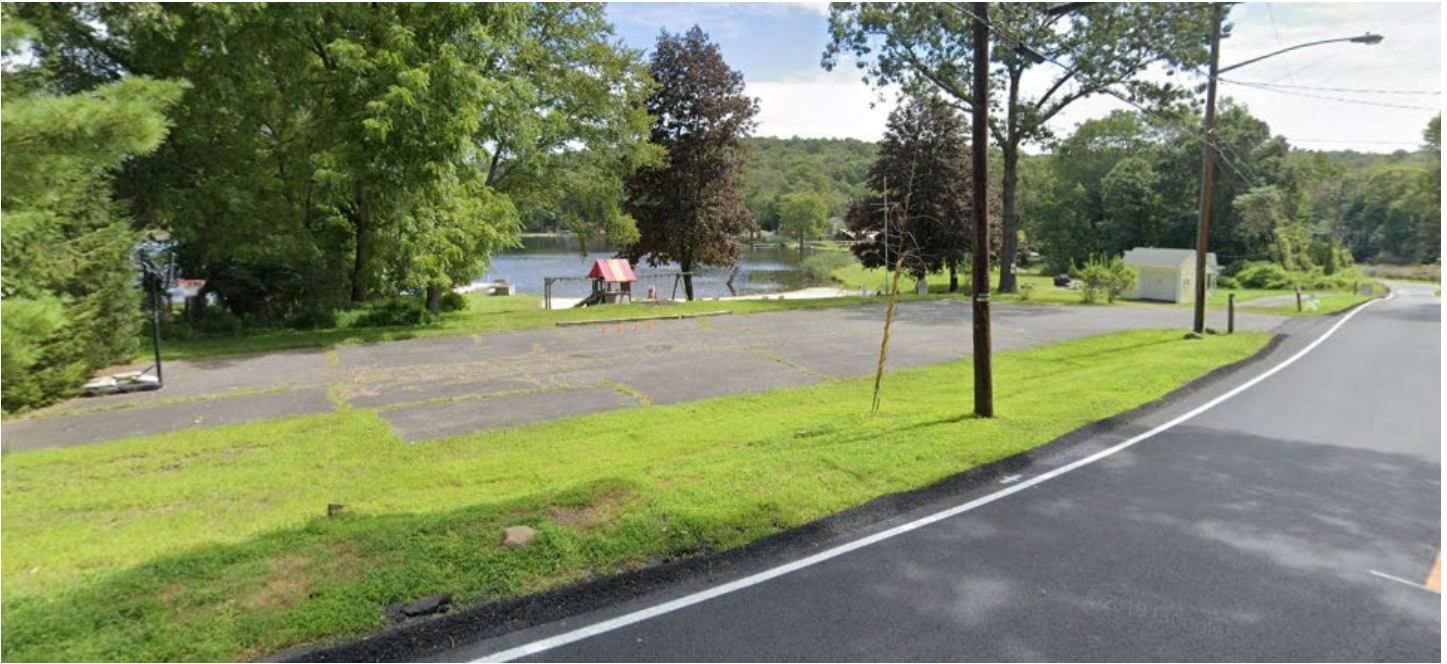
Photo 8-13: Parking area for Seneca Lake (Recommendation 10A)

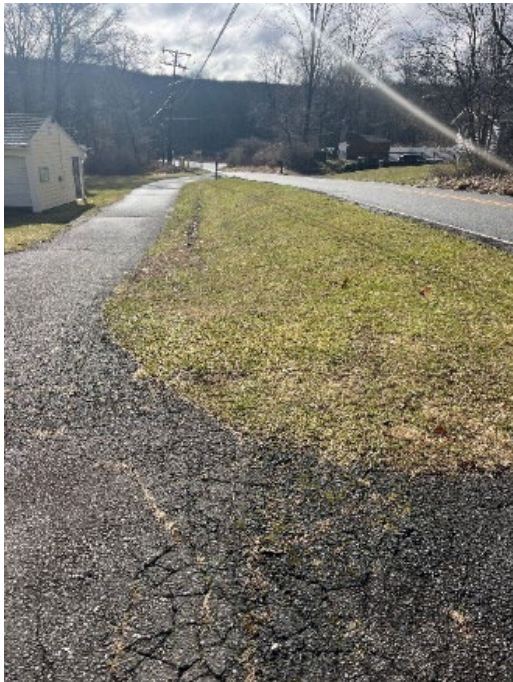
Photo 8-14: The grass area between Seneca Rd and the paved roadway to the parking lot (Recommendation 10B)

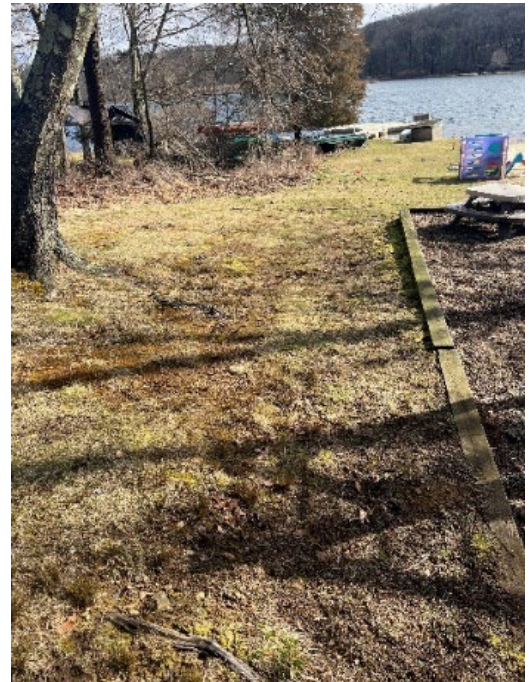
Photo 8-15: Erosion along the northwest side of the playground located in the beach area (Recommendation 10C)

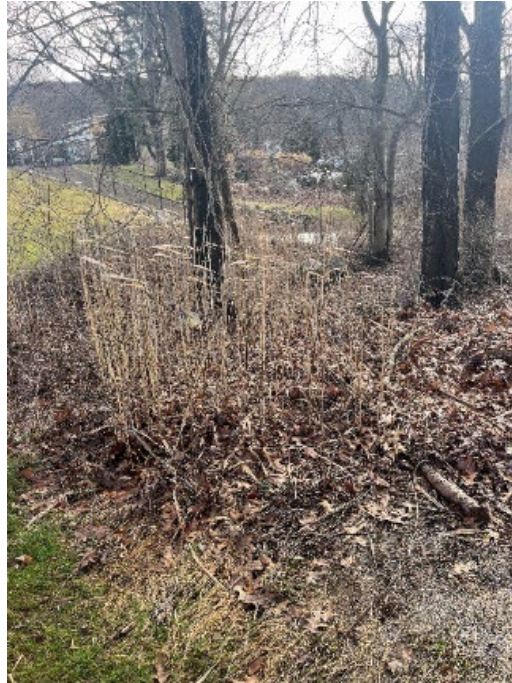
Photo 8-86: Common Reed (Phragmites australis) growing in the wetland by the outlet structure (Recommendation 10D)

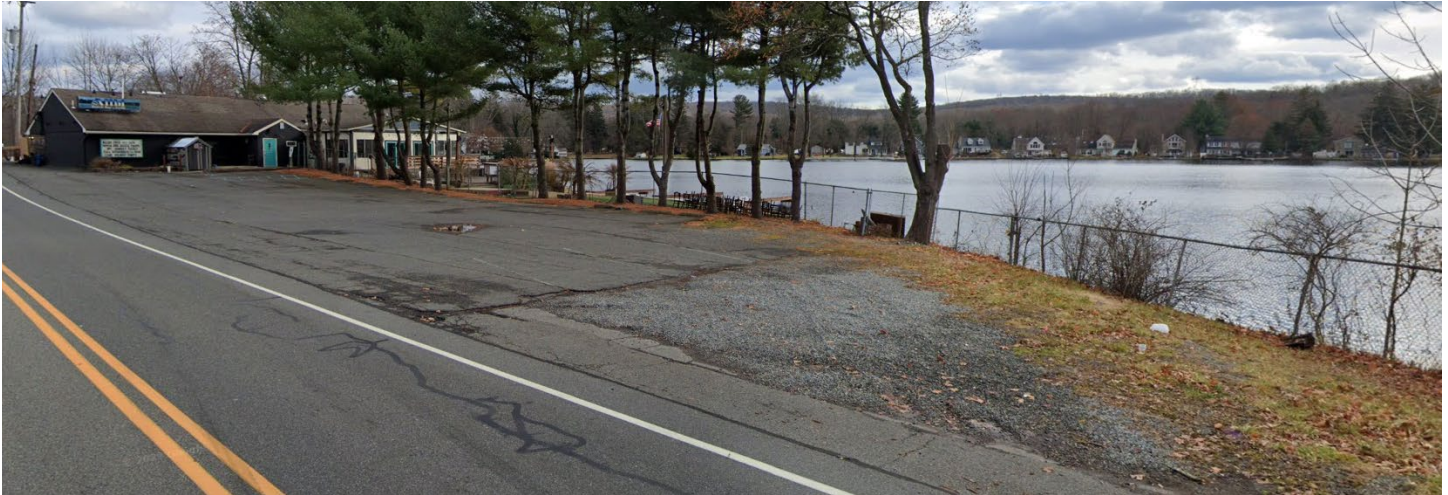
Photo 8-17: Southern parking lot of Alibi Bar & Grill (Recommendation 12A)

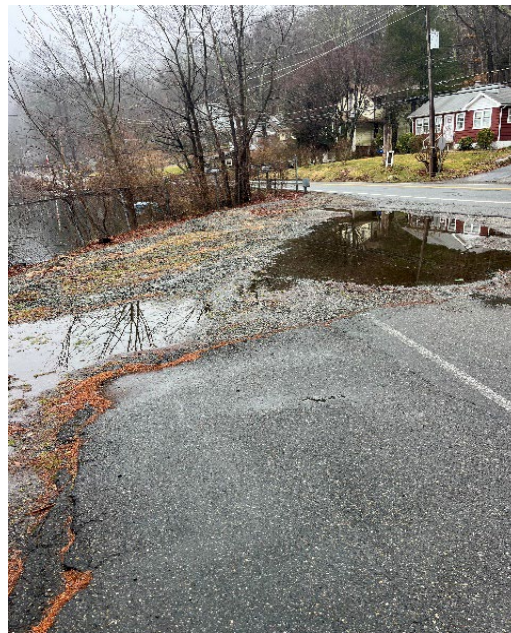
Photo 8-189: The south end of the parking lot with excess road gravel and pooled water (Recommendation 12B)

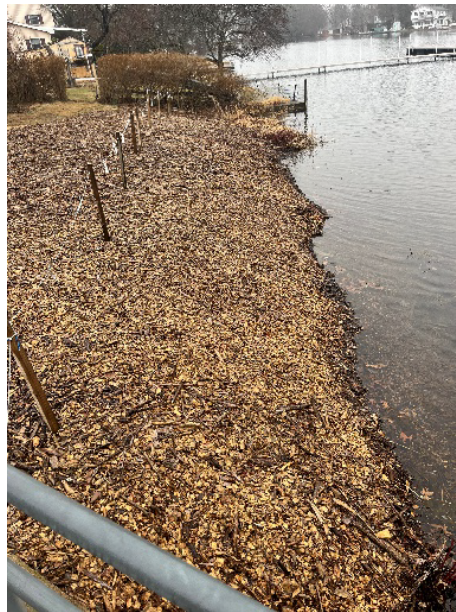
Photo 8-19: The mulched shoreline of the recreational area near the Lackawanna dam (Recommendation 12A)

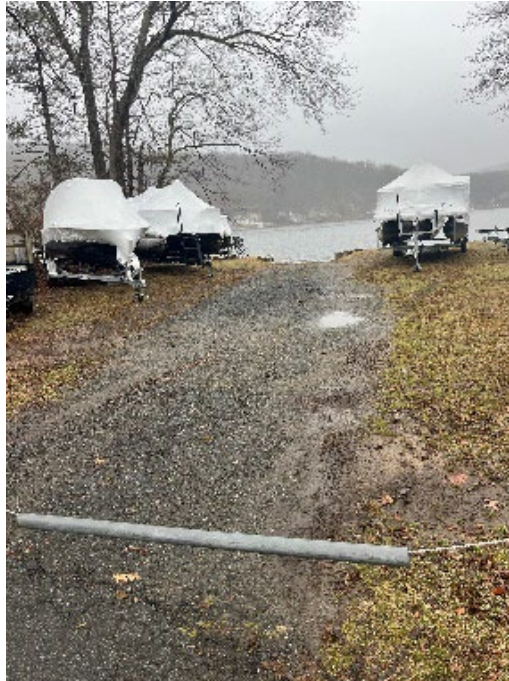
Photo 8-20: The boat launch and associated grass area of Lake Lackawanna (Recommendation 13A-13B)

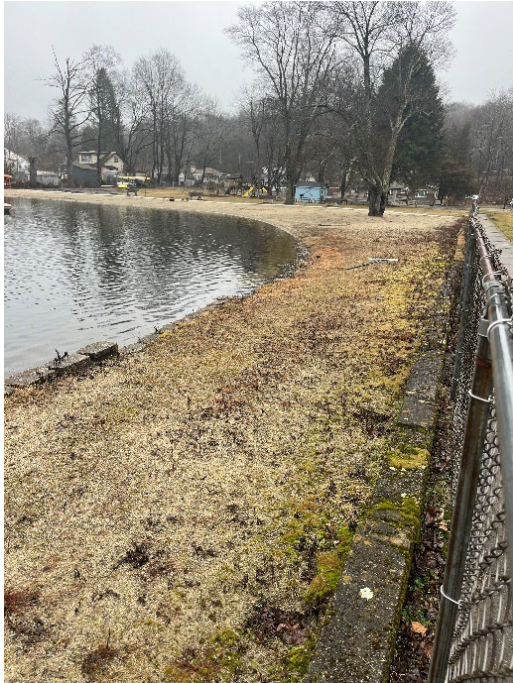
Photo 8-21: The beach from the dam of Lake
(Recommendation 14A)

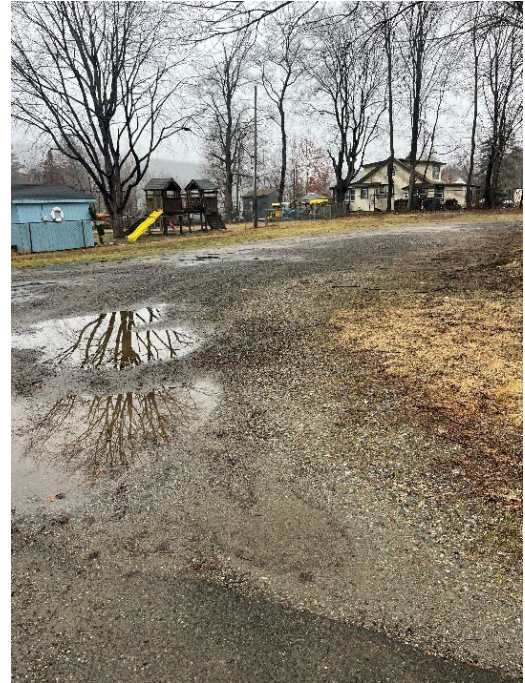
Photo 8-22: The parking lot outside of the
Lackawanna beach (Recommendation 14B)

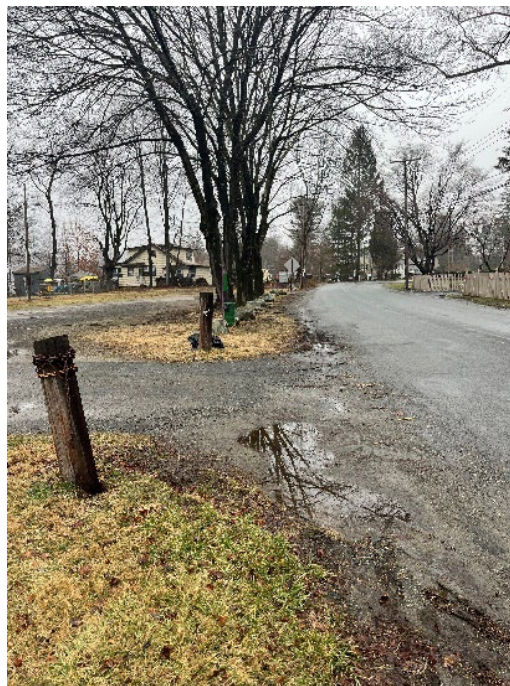
Photo 8-23: The area where the parking lot meets Lake Dr
(Recommendation 14C)

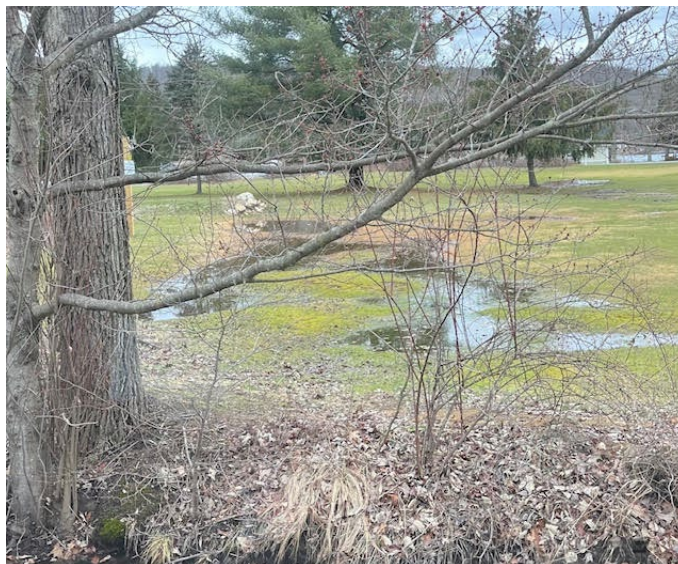
Photo 8-24: Standing water behind the 1st green on the Lackawanna golf course along Reis Ave (Recommendation 15A)

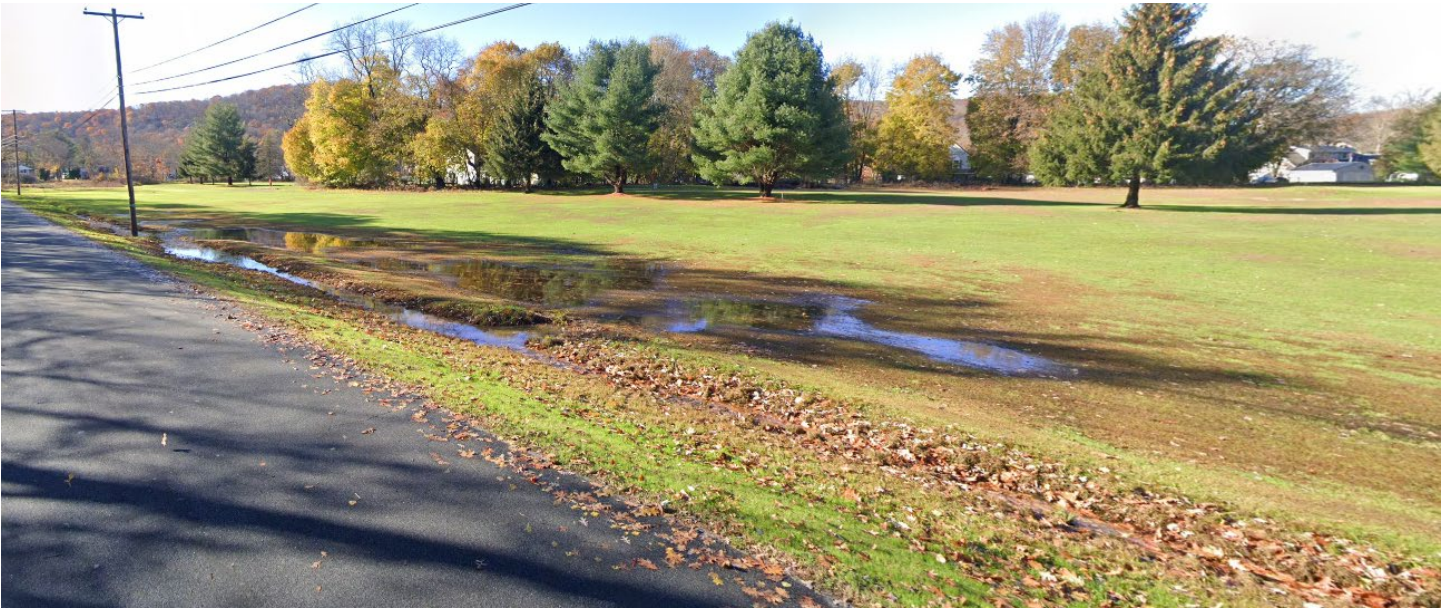
*Photo 8-25: Standing water on the 1st fairway along Reis Ave
(Recommendation 15B)*

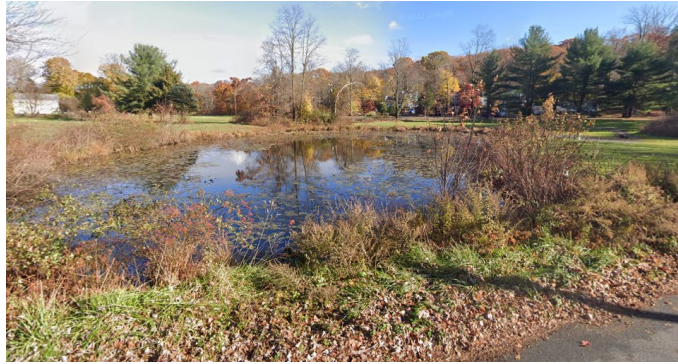
*Photo 8-26: Pond near the 3rd tee that drains into Lake Lackawanna
(Recommendation 16A)*

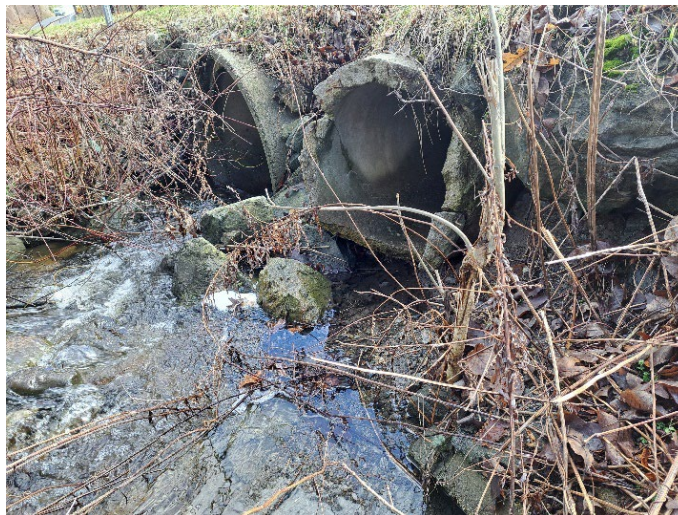
*Photo 8-10: Upstream view of culverts that cross under Sparta Rd
(Recommendation 17A)*

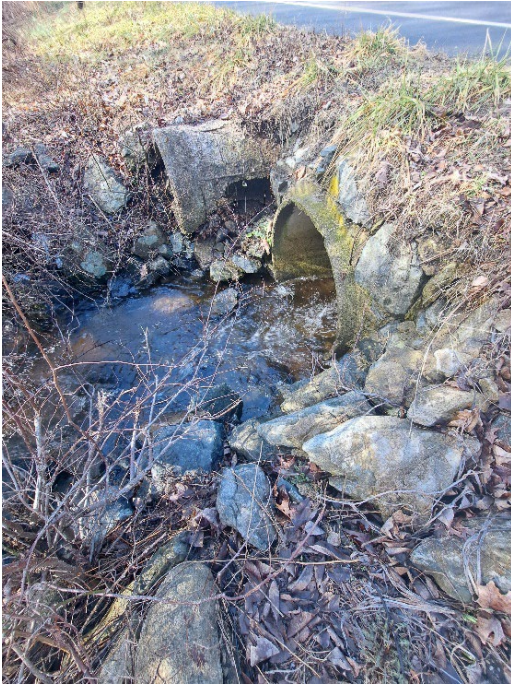
Photo 8-28: Upstream view of culverts that cross under Sparta Rd (Recommendation 17A)

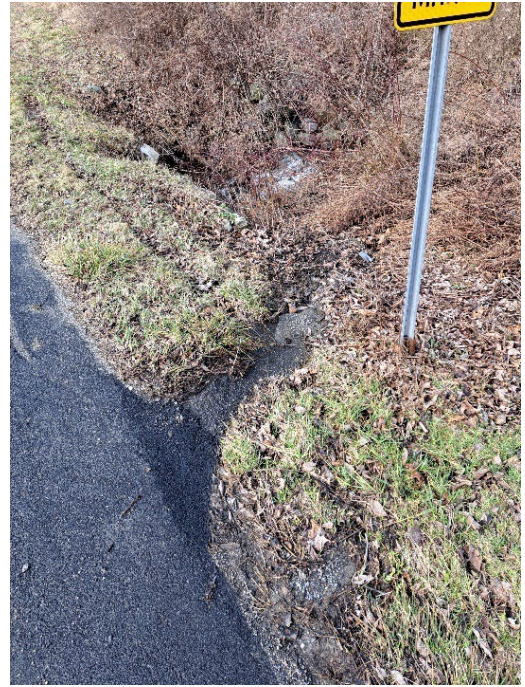
Photo 8-29: Rill draining into an un-named tributary eroding along Sparta Rd (Recommendation 17A)

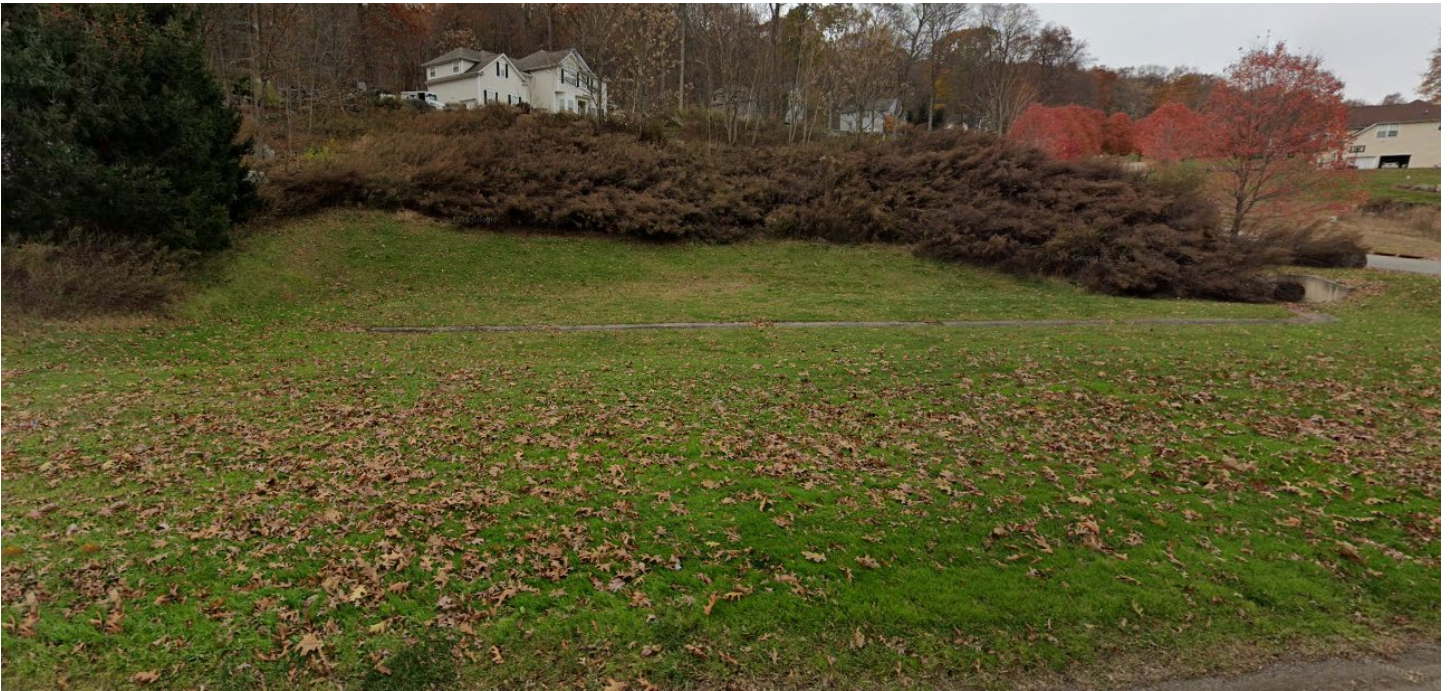
Photo 8-30: Southern retention basin at intersection of Ascot Ln and Sparta Rd (Recommendation 18A)

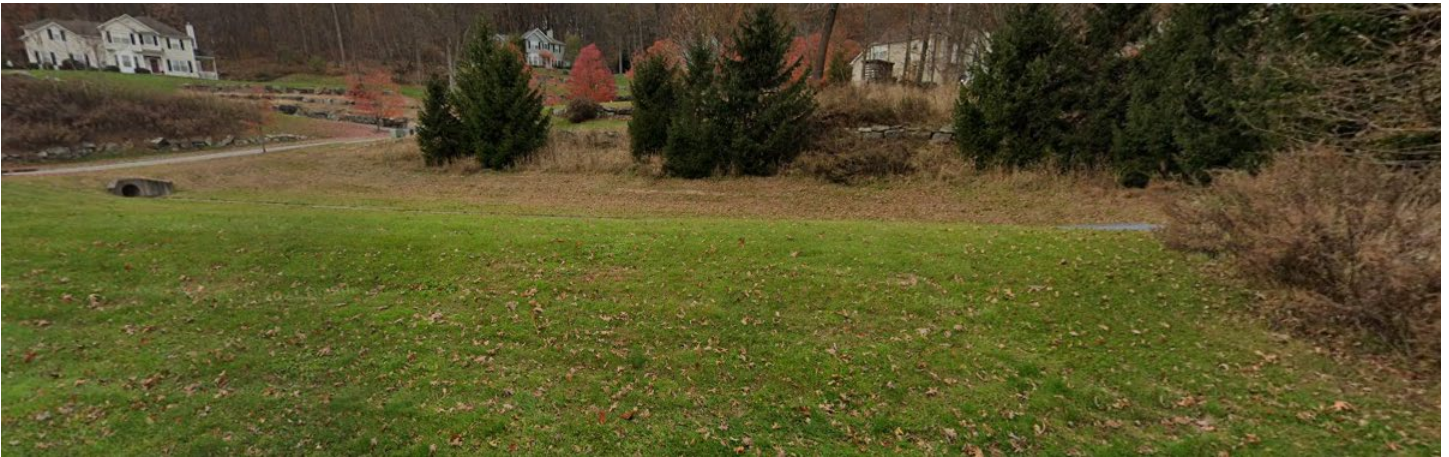
Photo 8-31: Northern retention basin at intersection of Ascot Ln and Sparta Rd (Recommendation 18A)

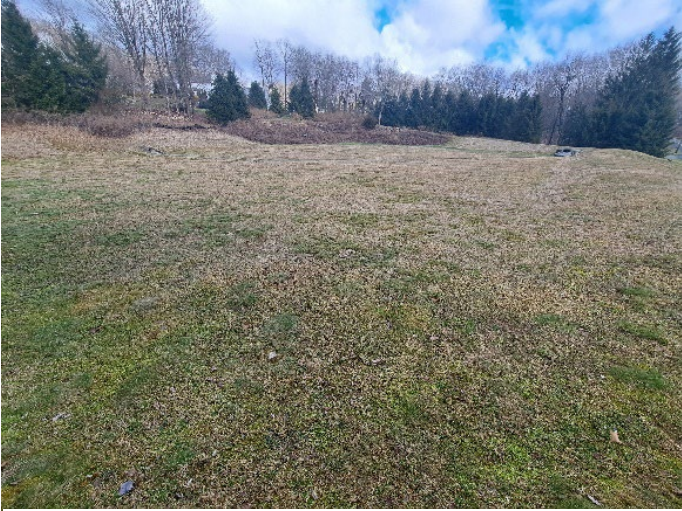
Photo 8-32: Drainage basin at the Ascot/Sparta Rd intersection (Recommendation 18A)

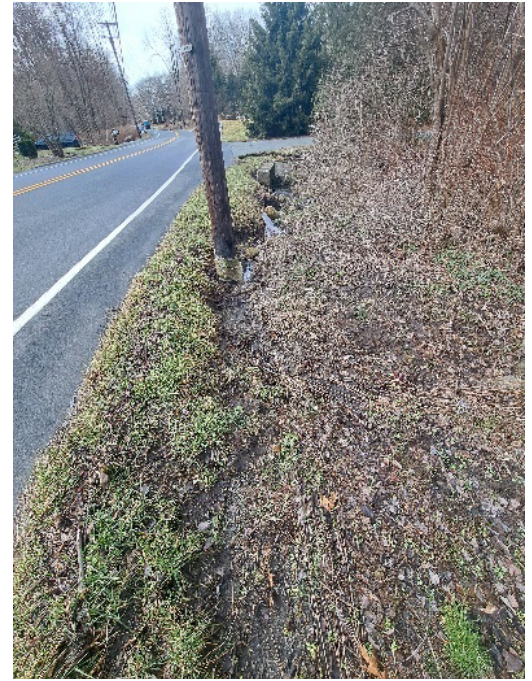
Photo 8-33: Active erosion around utility pole from stormwater runoff (Recommendation 18B)

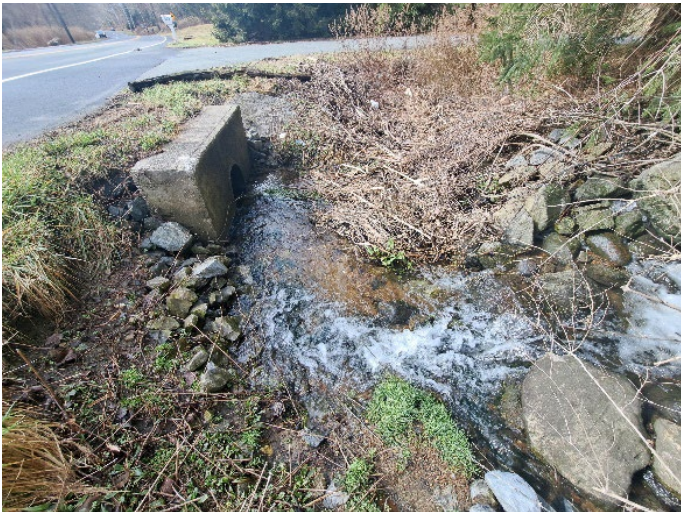
Photo 8-34: Downstream section of culvert showing exposed HDPE pipe and potential for erosion along edge of the road (Recommendation 18B)

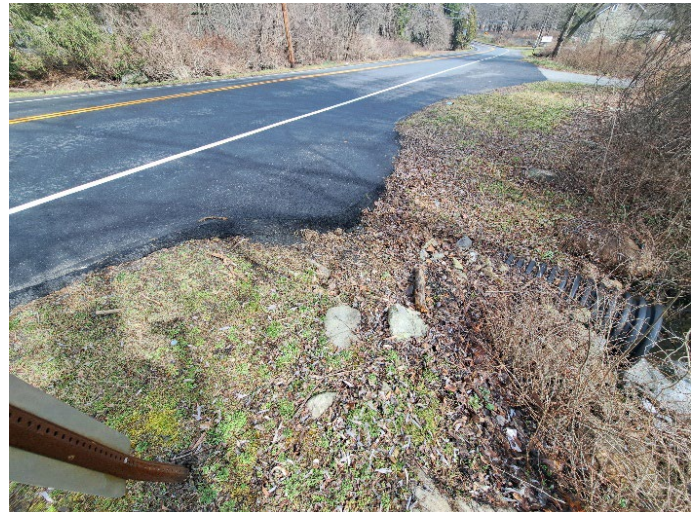
Photo 8-35: Misaligned channel and bank erosion along culvert headwall (Recommendation 18B)

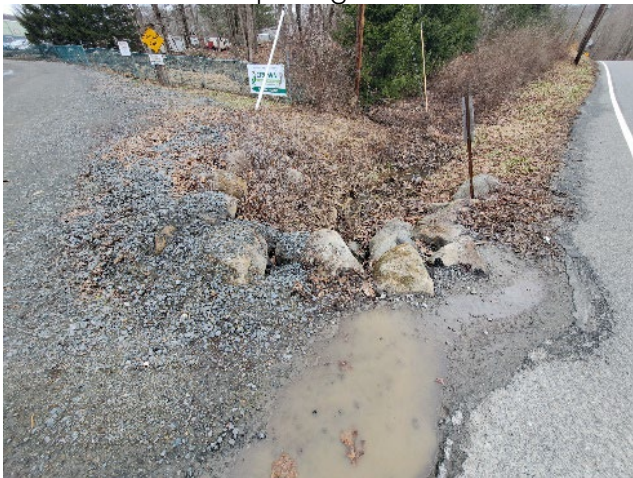
Photo 8-36: View of driveway material being plowed into the drainage swale (Recommendation 19A)

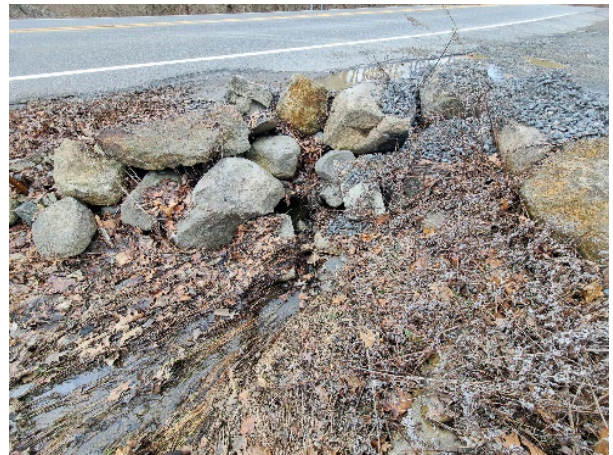
Photo 8-37: The culvert is being partially blocked by the riprap and is becoming clogged with driveway material and plant matter (Recommendation 19A)

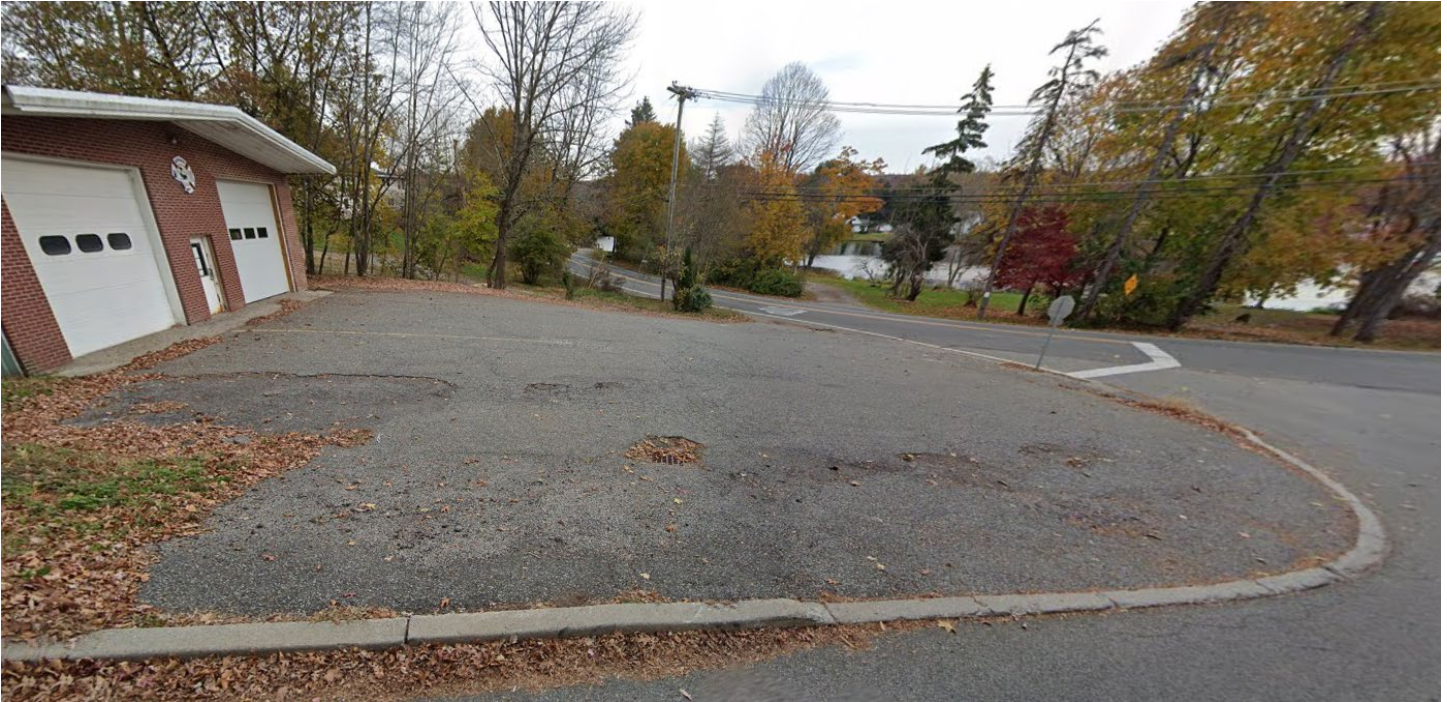
*Figure 8-38: Byram Fire Department Parking lot as seen from Roseville Rd
(Recommendation 20A)*

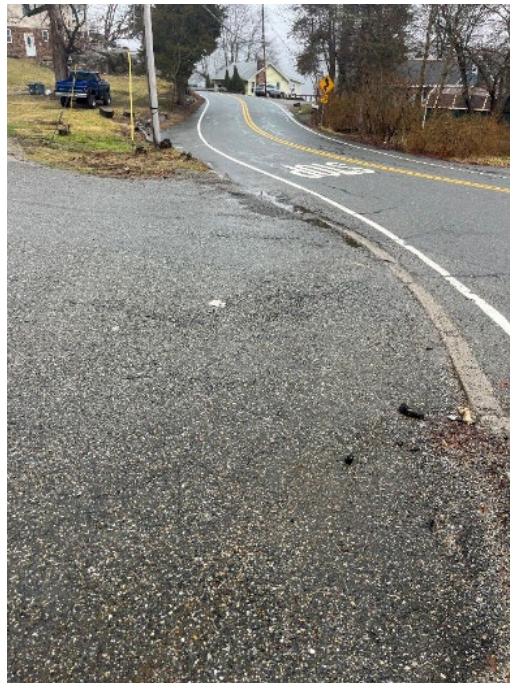
*Photo 8-39: Byram Fire Department Parking lot looking north on
Lackawanna Dr (Recommendation 20A)*

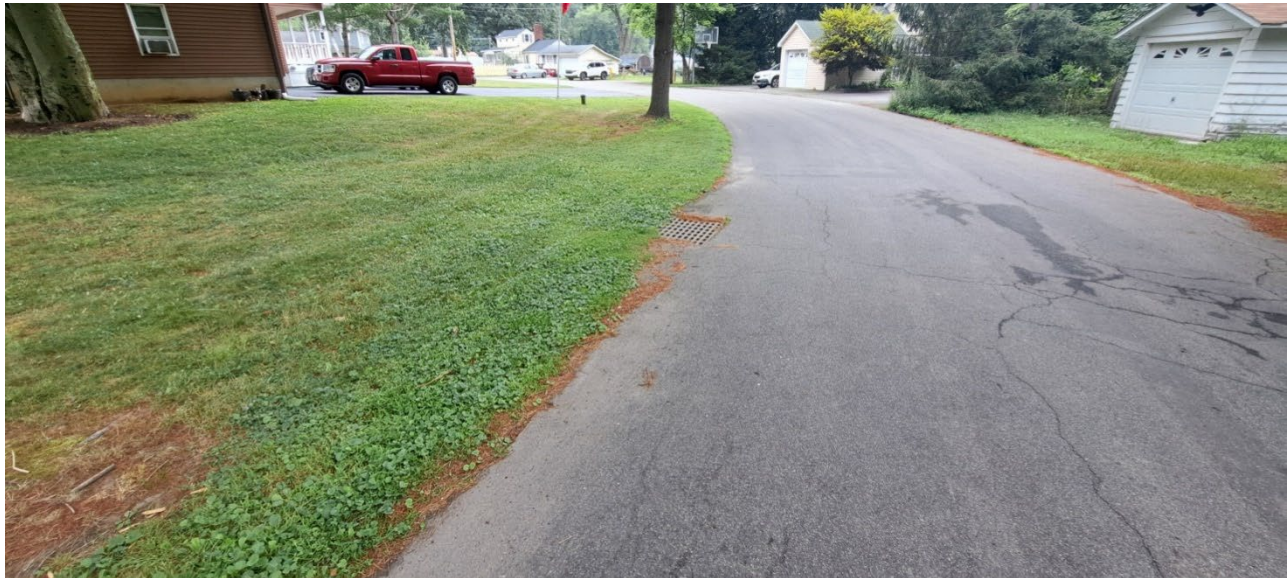
Photo 8-40: Showing a suitable location for a roadside rain garden (45 Richmond Rd.)

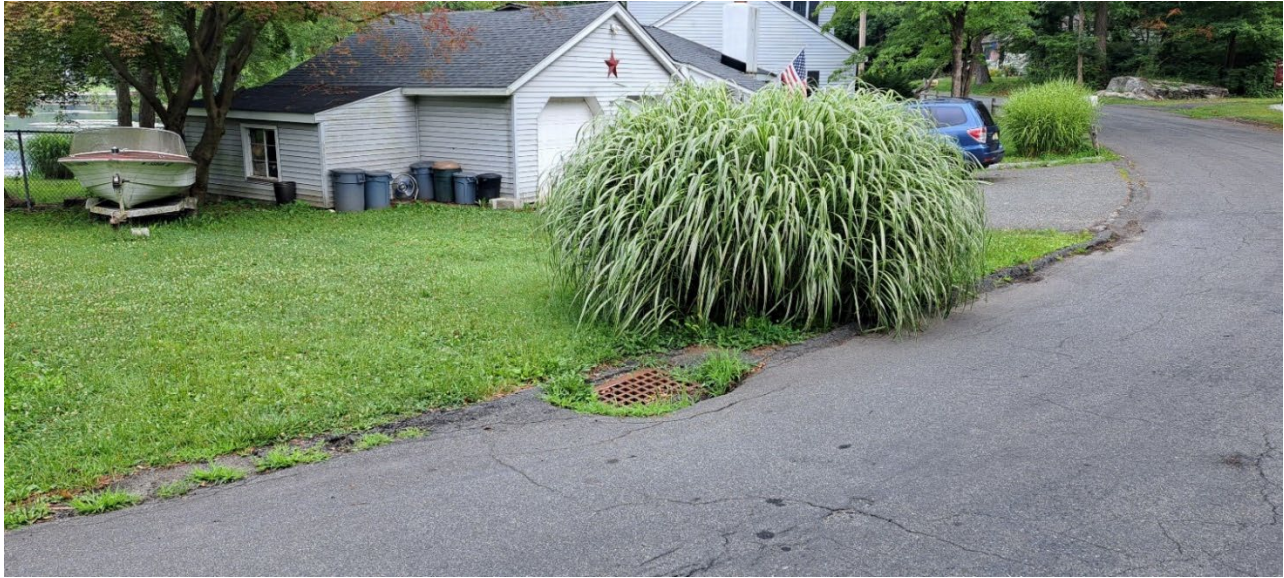
Photo8-42: Showing a suitable location for a roadside rain garden (210 Lake Dr.)

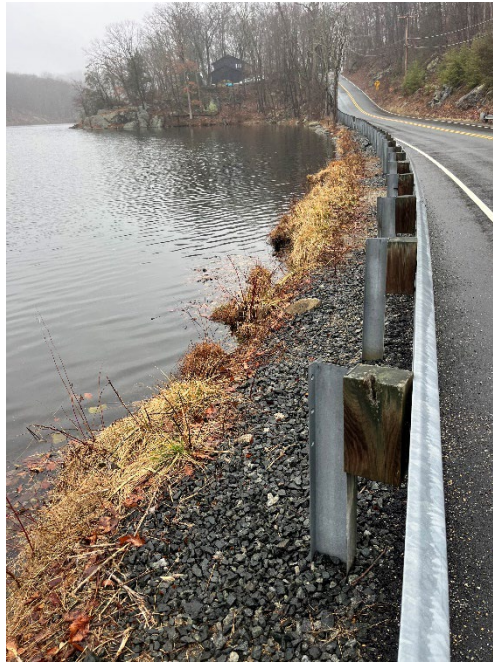
Photo 8-46: The shoreline of Johnson Lake along Tamarack Rd

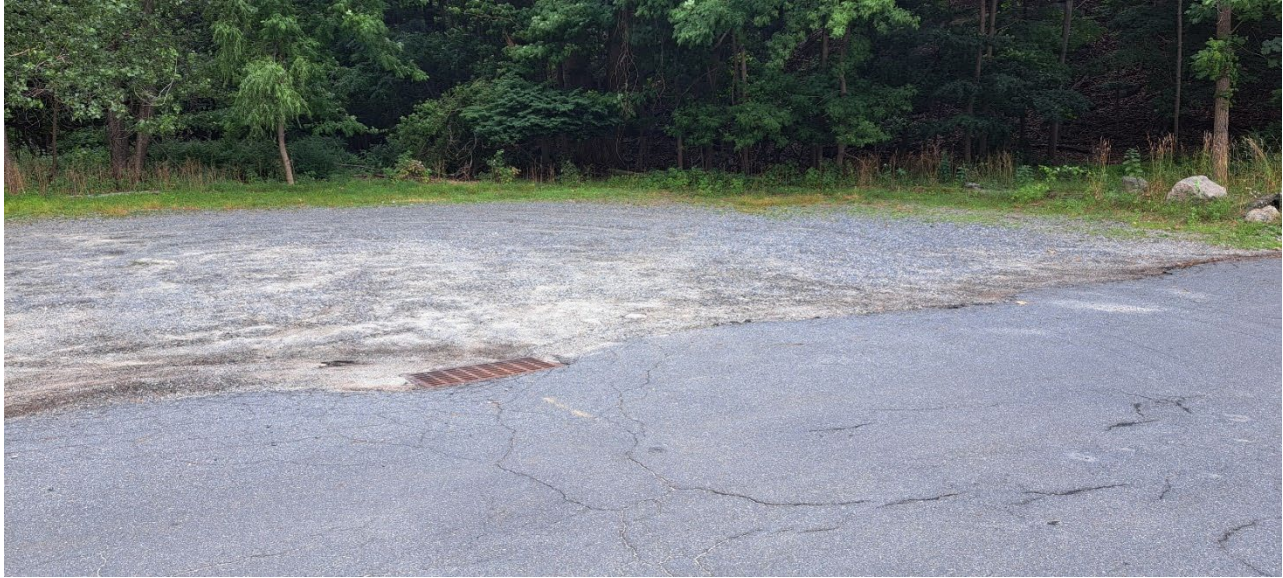
Photo 8-47: Compacted gravel/rock dust parking lot across from the Forest Lake Dr Beach

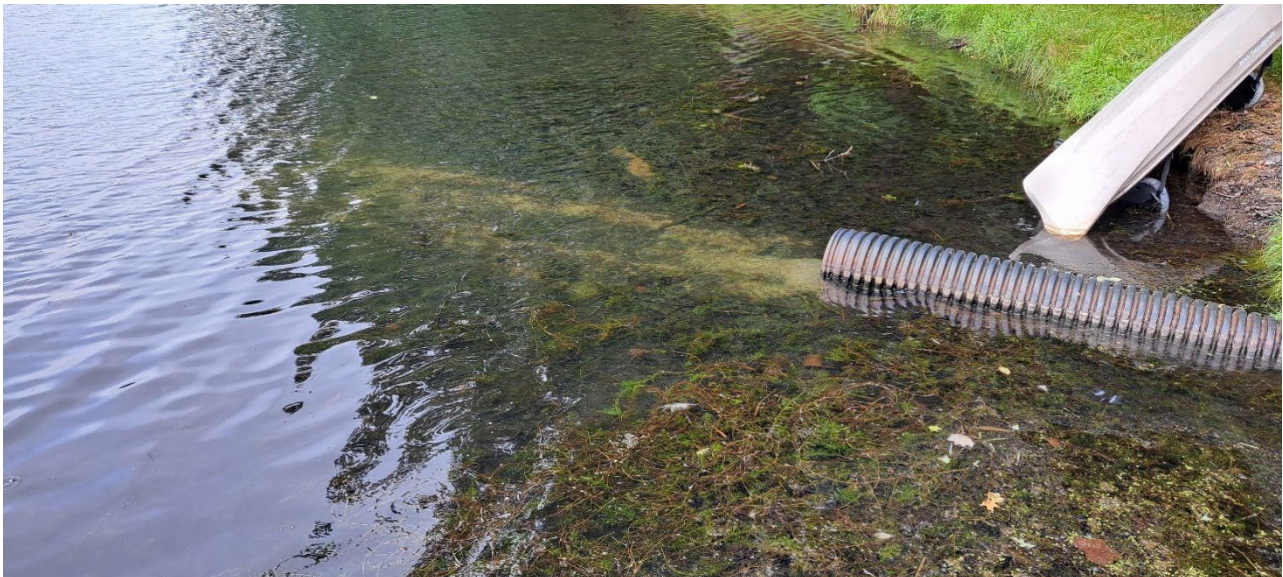
Photo 8-48: Sediment can be seen at the end of the stormwater pipe discharging from the adjacent parking lot. The pipe was also laden with gravel and sediment

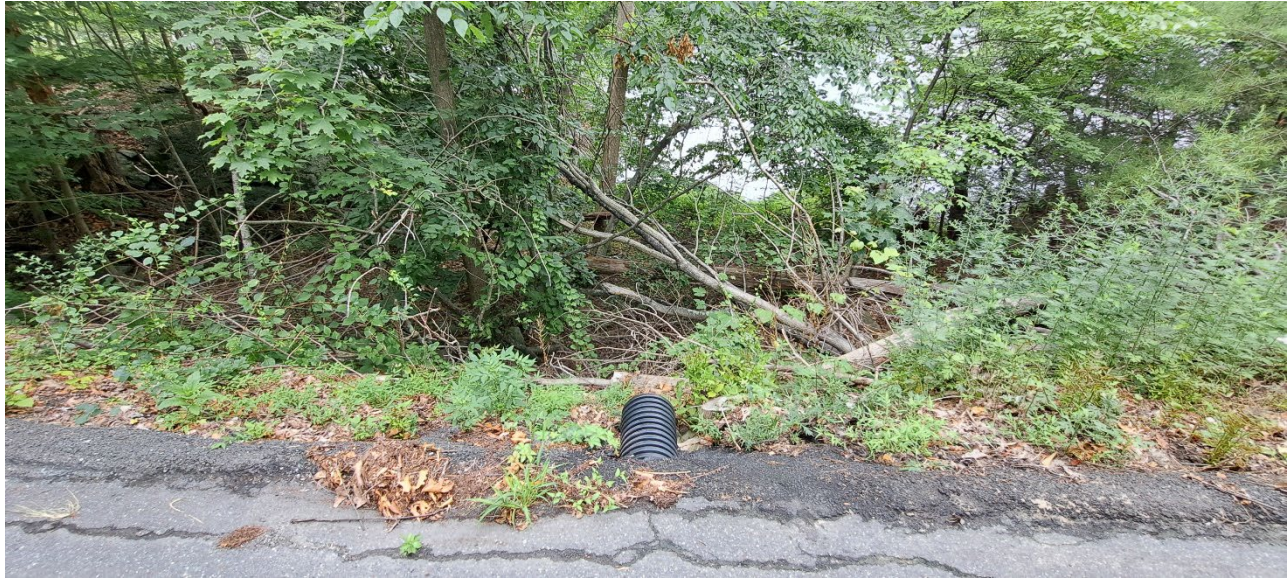
Photo 8-52: Discharge pipe causing a moderate amount of erosion below the pipe

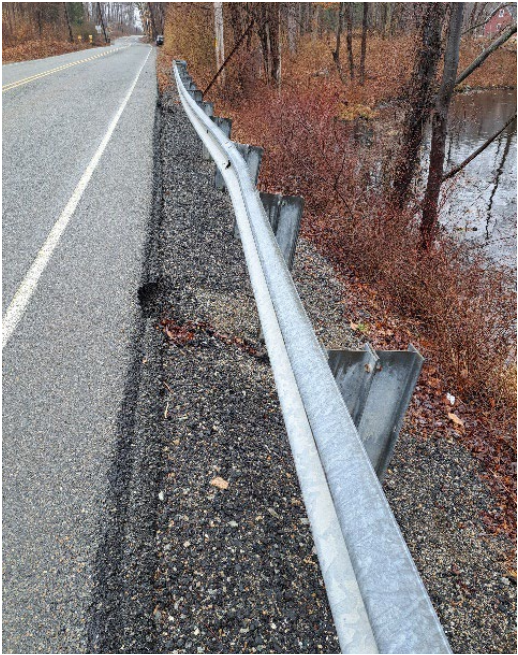
Photo 8-53: Erosion forming along the Roseville road base (Recommendation 30A)

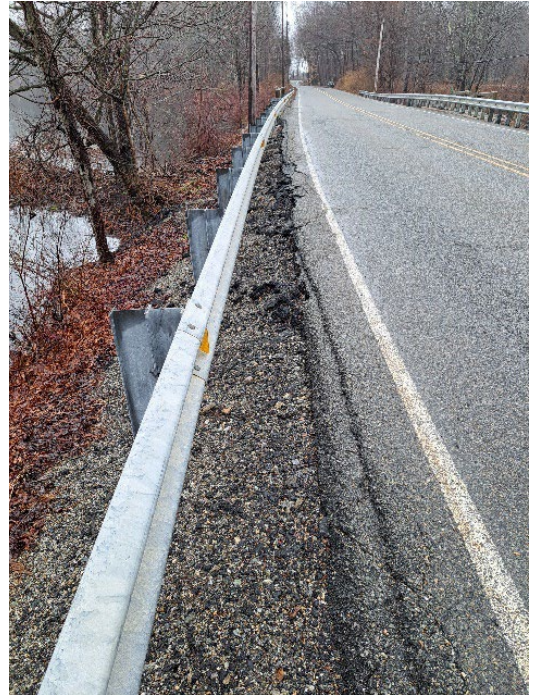
Photo 8-54: Shows edge of road degrading from surface runoff and gravel washout (Recommendation 30A)

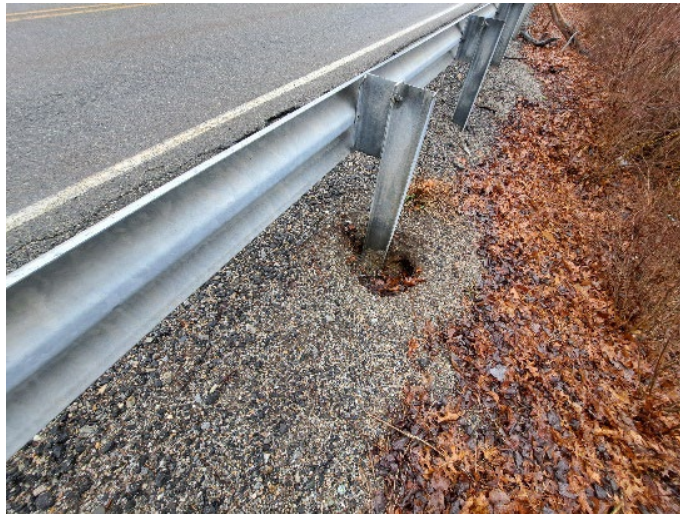
Photo 8-55: Scour hole is being formed along the guardrail support from stormwater runoff (Recommendation 30A)

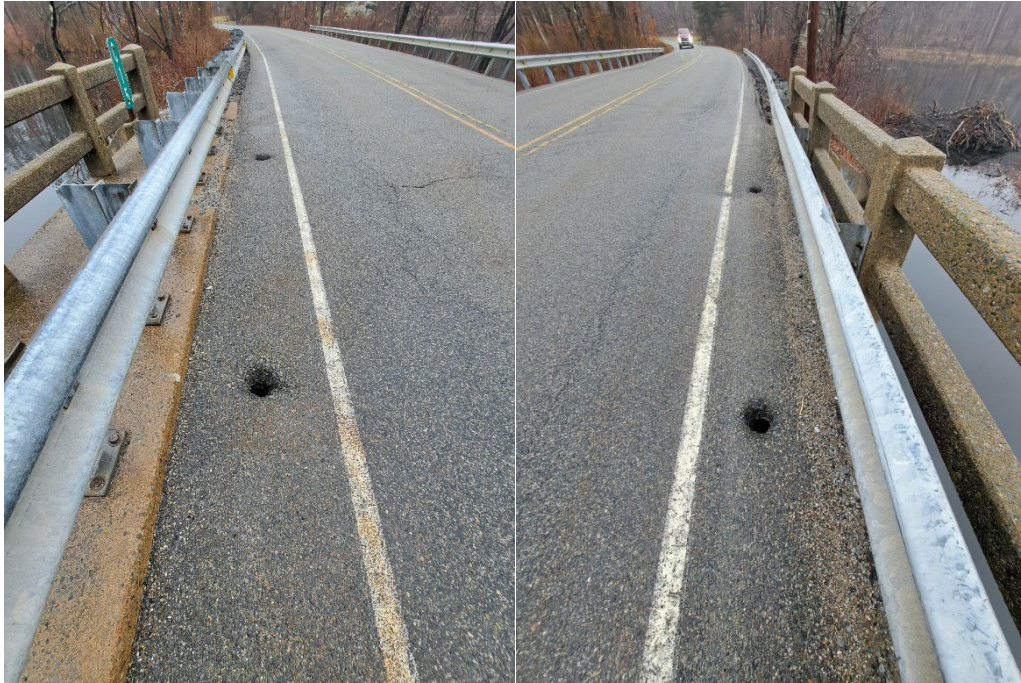
*Photo 8-56: Holes to drain road runoff directly into Wolf Lake
(Recommendation 30B)*
