TOWNSHIP OF BYRAM LAKES AND WATERSHEDS MANAGEMENT PLAN

TOWNSHIP OF BYRAM, SUSSEX COUNTY, NEW JERSEY

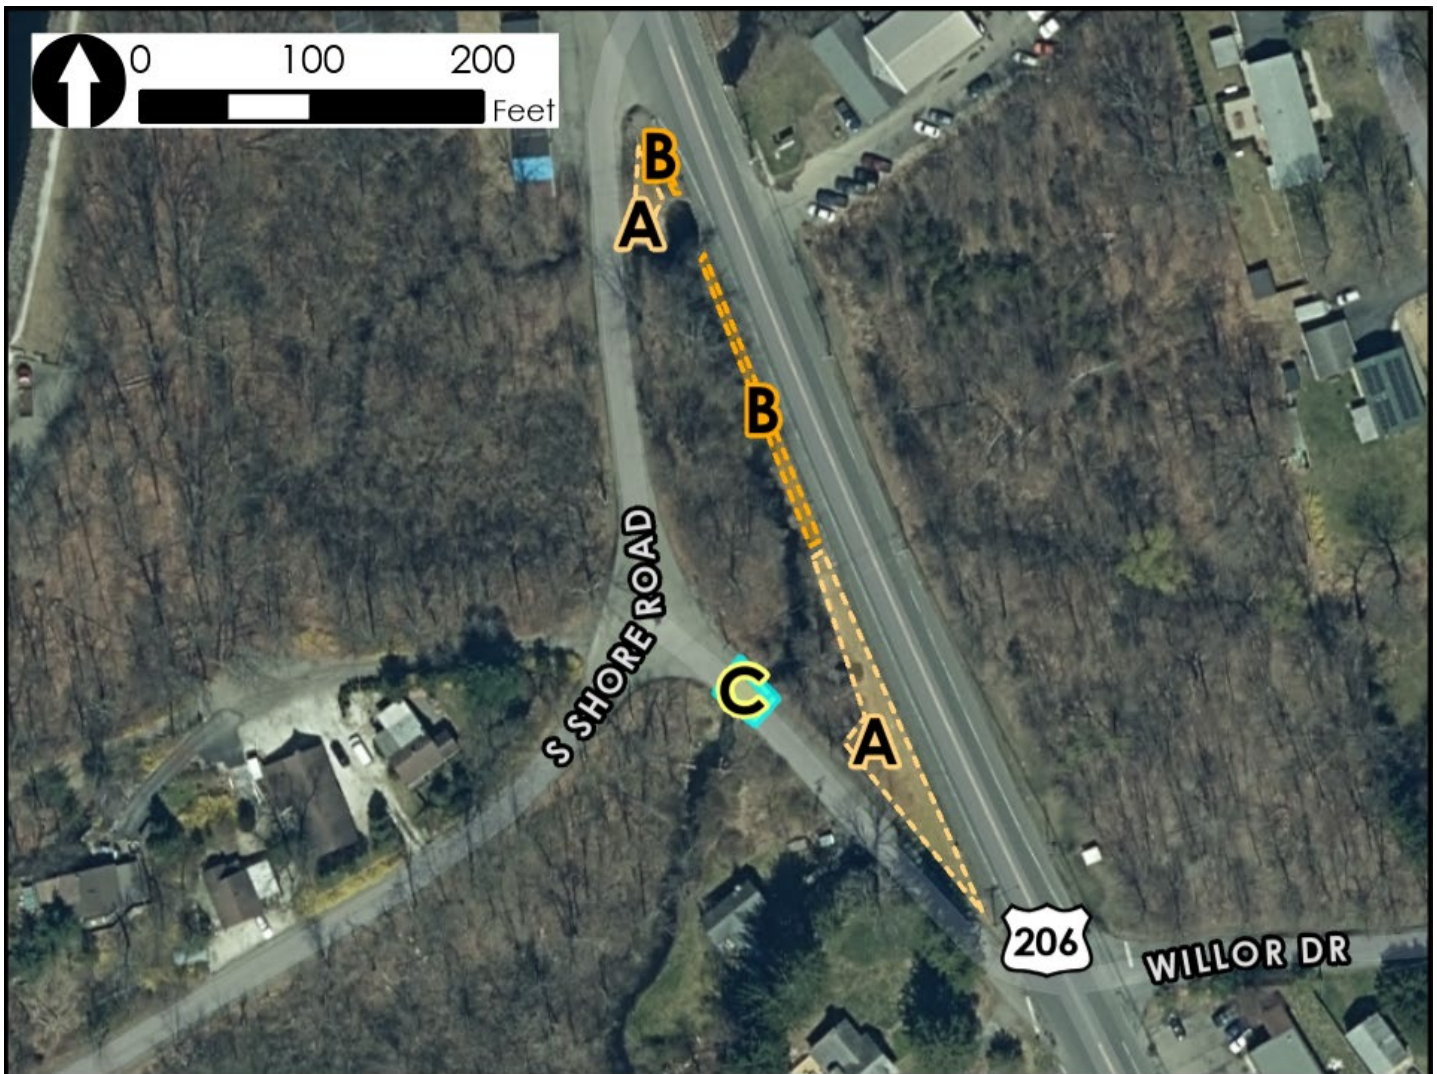
Site 31, with an estimated drainage area of 210,000 square feet, is comprised of a depression between Route 206 and S Shore Rd. Within this depression is the confluence of Ghost Pony Brook and two un-named tributaries that drain nearby wetland areas. Ghost Pony enters the depression via an adequately sized bridge crossing under 206 while the two un-named tributaries enter via concrete or steel culverts. The flow leaves the depression by way of a bridge crossing along S Shore Rd. This bridge crossing on S Shore Rd is showing signs of deterioration to its railing and support beams. There is also evidence of erosion occurring at abutments from flooding events.

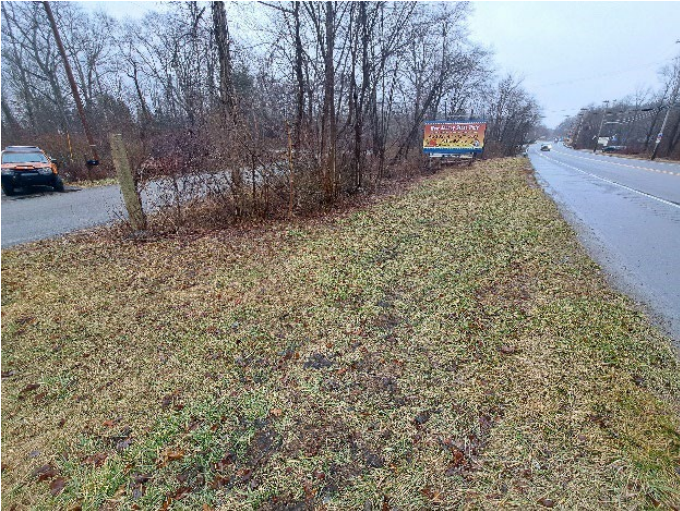
Photo 8-57: Lawn area between S Shore Rd and Rt 206

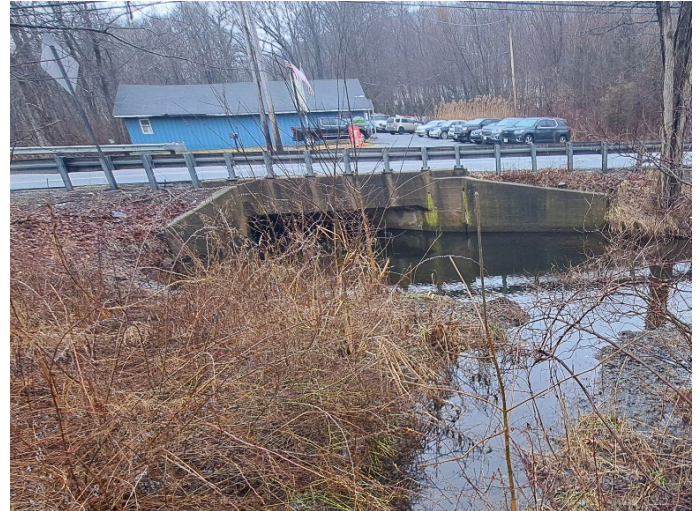
Photo 8-58: 206 crossing of Ghost Pony Brook [Site Inlet]
(Recommendation 31A)

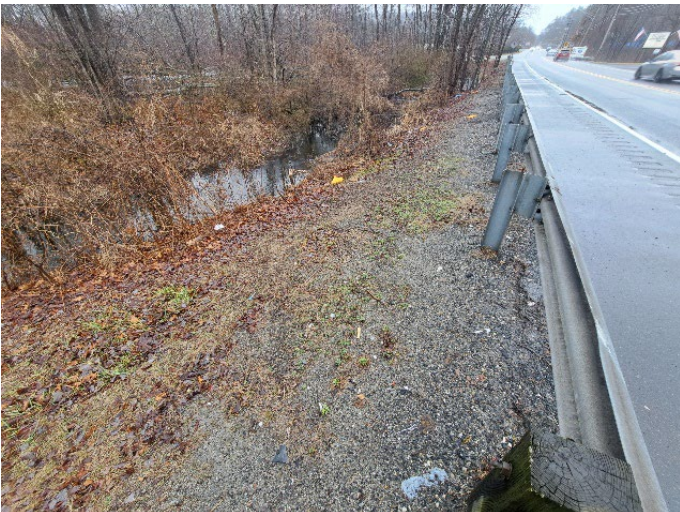
Photo 8-59: Gravel bank by guardrail along 206
(Recommendation 31B)

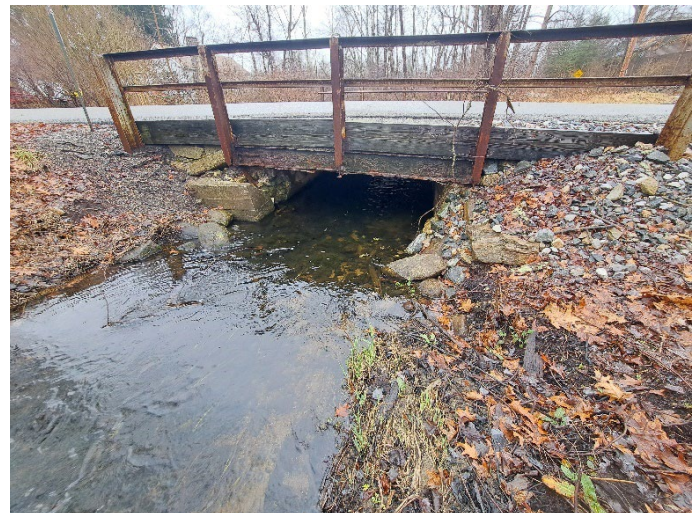
Photo 8-60: S Shore Rd bridge crossing [Site Outlet]
(Recommendation 31C)

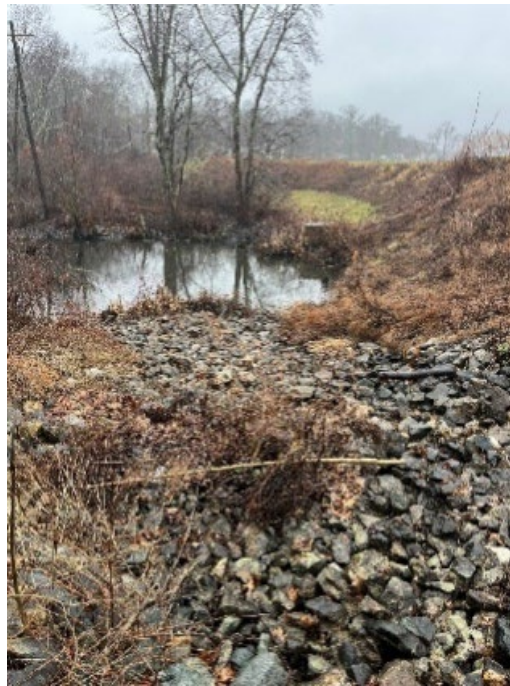
Photo 8-61: Cranberry Lake pond (Recommendation 32A)

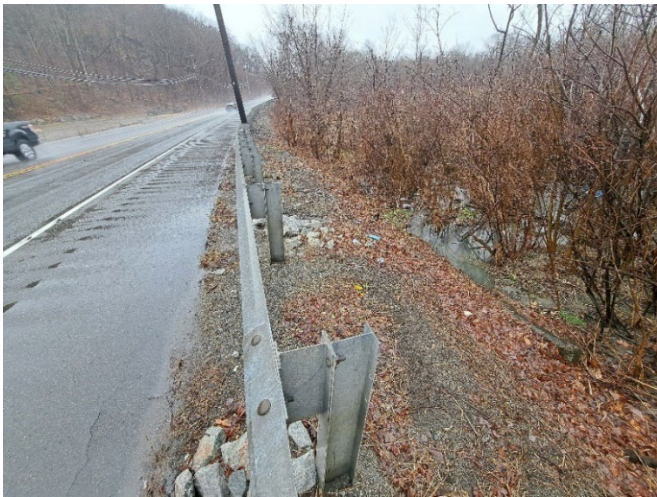
Photo 8-62: Gravel bank along Route 206 south towards Sutton Ln (Recommendation 33A)

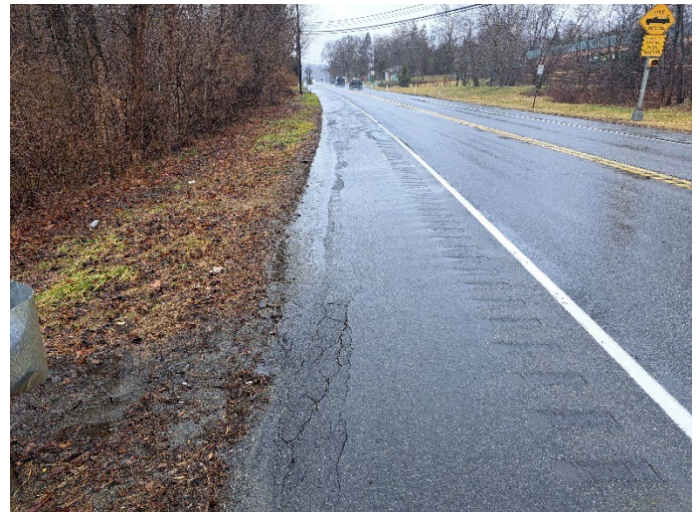
Photo 8-63: Storm run-off runs along the shoulder of Rt. 206 (Recommendation 33A)

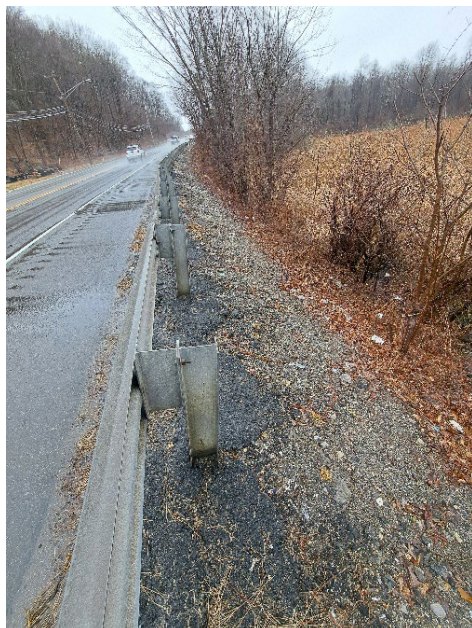
Photo 8-64: Gravel bank along Route 206 south towards Sutton Ln (Recommendation 33A)

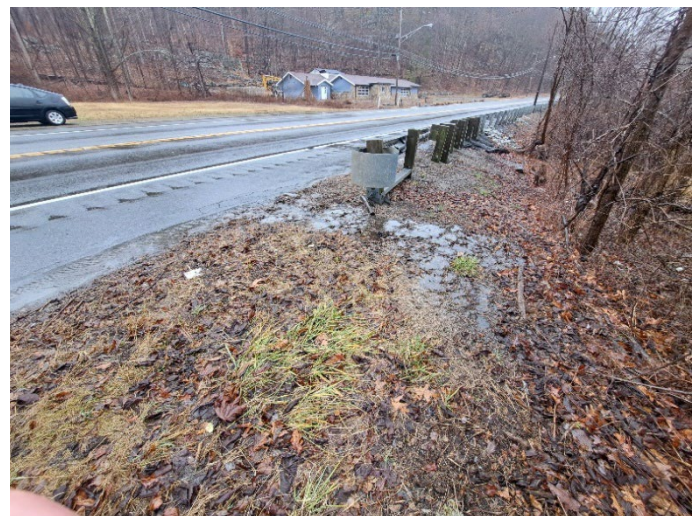
Photo 8-65: Storm runoff rills in front of guardrail toward wetland complex (Recommendation 33B)

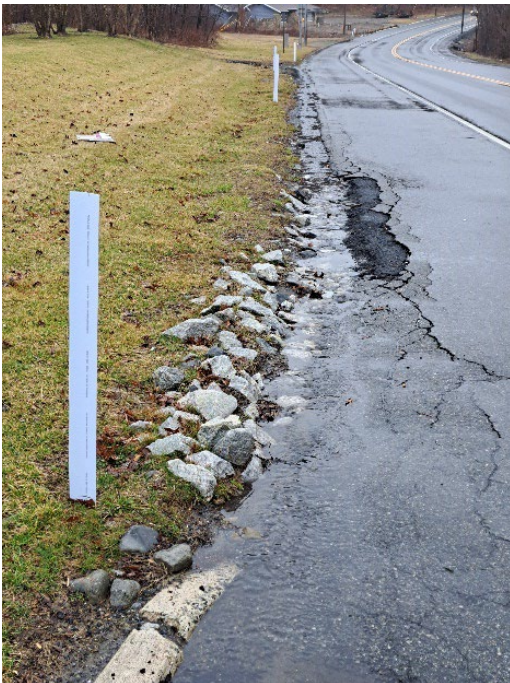
Photo 8-66: Stormwater Runoff along Rt 206
North in front of Metro Self Storage
(Recommendation 34A)

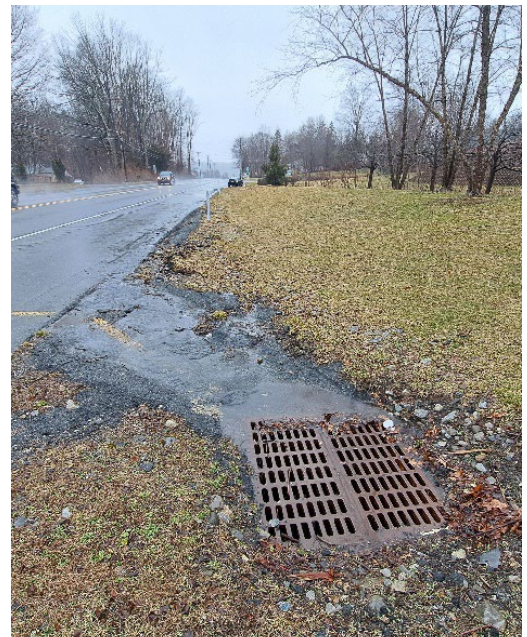
Photo 8-67: Stormwater Runoff along Rt 206
North in front of Metro Self Storage
(Recommendation 34A)

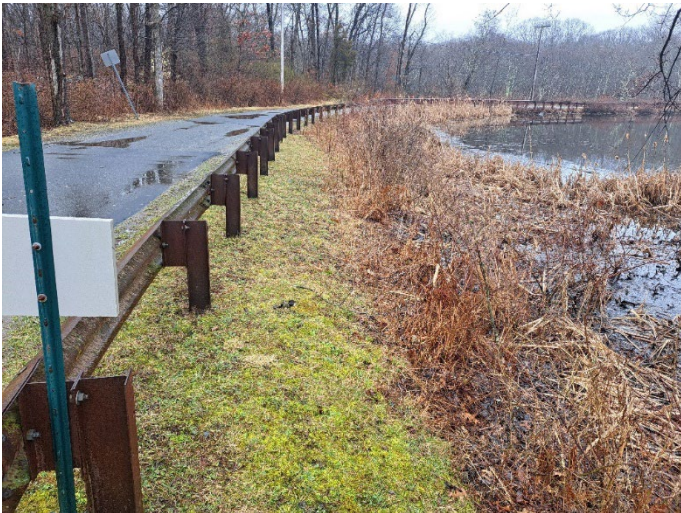
Photo 8-68: Area along Jefferson Lake Rd where a no-mow zone is recommended (Recommendation 35A)

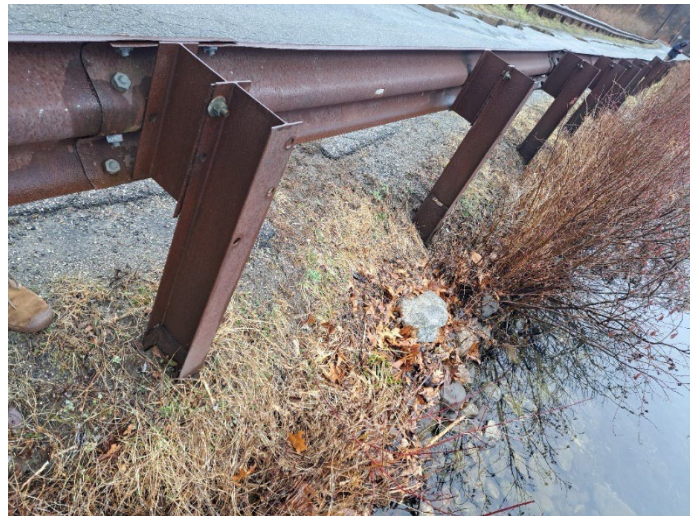
Photo 8-69: Shore erosion around rusting guardrail posts (Recommendation 35B)

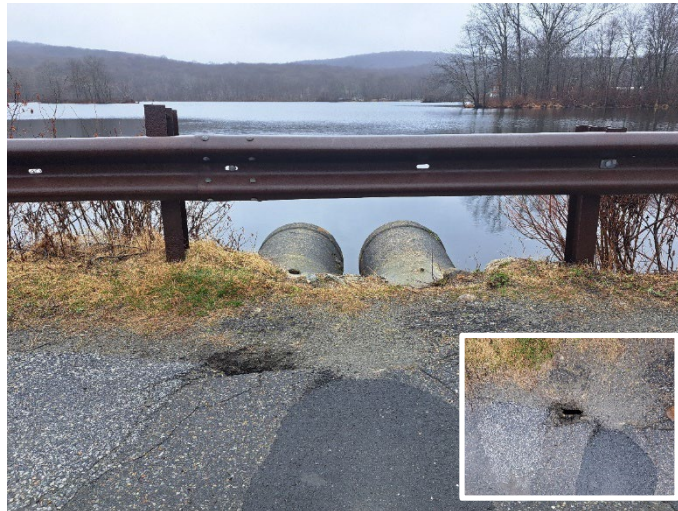
Photo 8-70: View of the overflow culverts looking toward Jefferson Lake. The inset is an overhead view of the hole in the road deck that drains into the culvert on the left (Recommendation 35C)

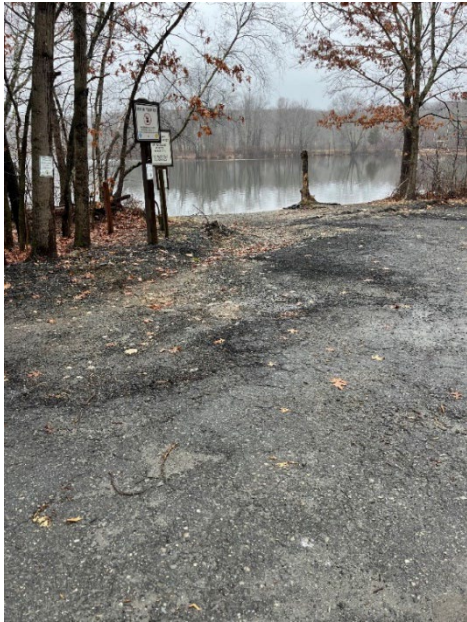
Photo 8-71: Jefferson Lake Boat Launch
(Recommendation 36A)

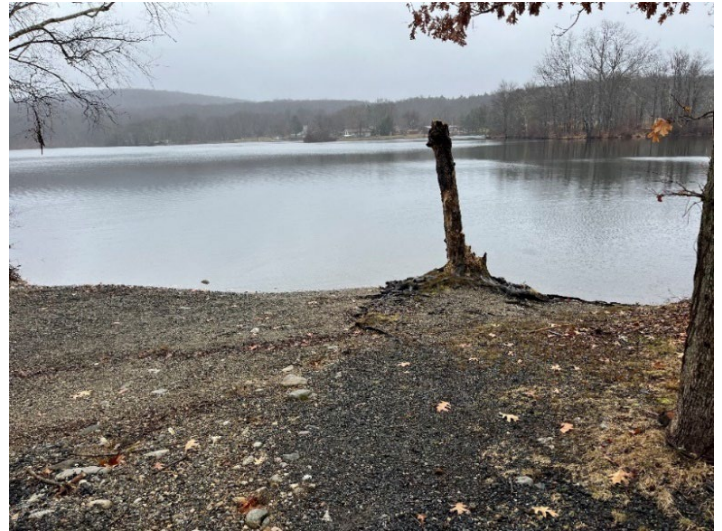
Photo 72: Existing snag and erosion along the Jefferson
Lake boat launch (Recommendation 36A)

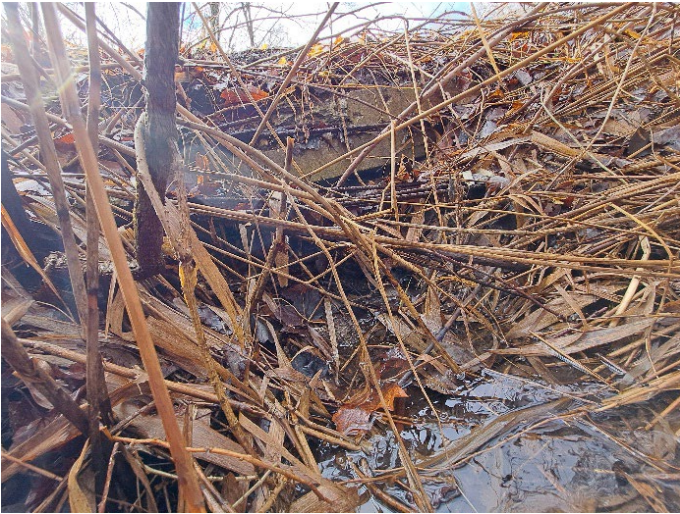
Photo 8-73: Upstream side of culvert (Recommendation 37A)

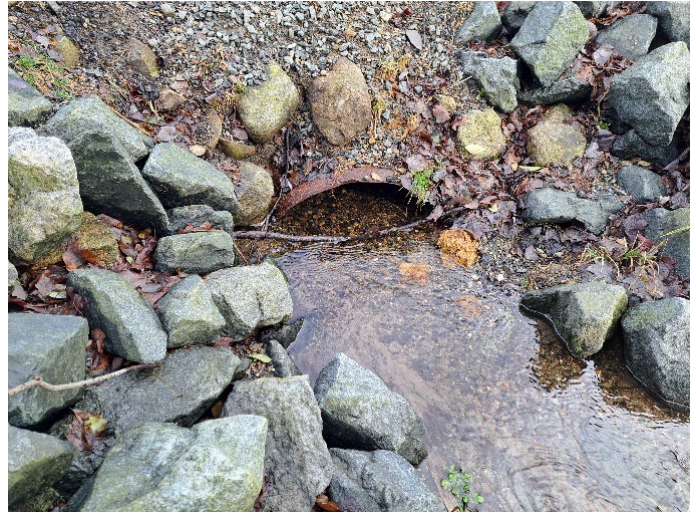
Photo 8-74: Downstream side of culvert (Recommendation 37A)

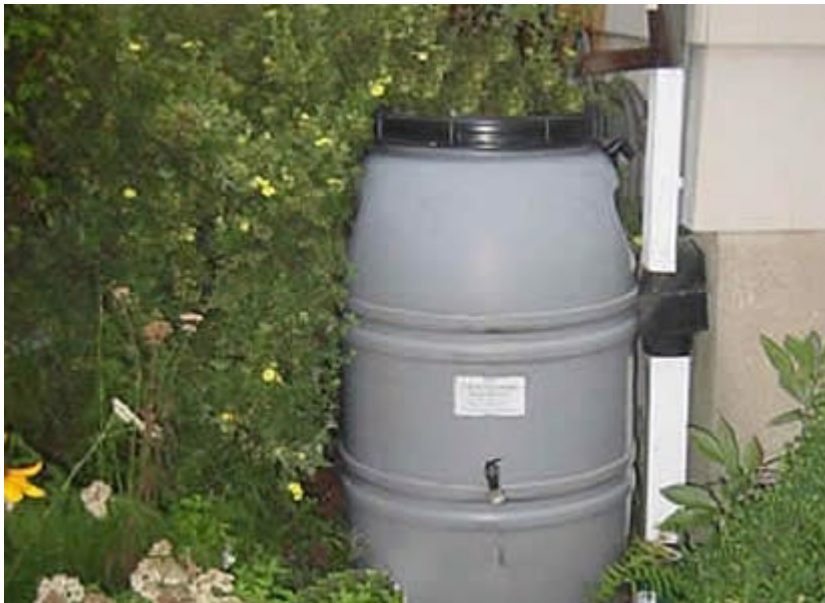
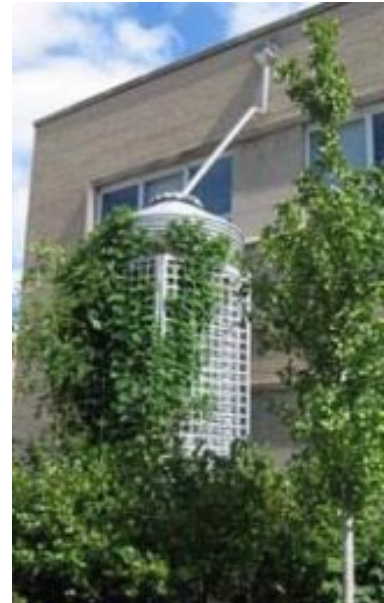
Photo 9.3: Rain barrel (left) and cistern (right), Sources: CT DEEP (left) and USEPA (right)

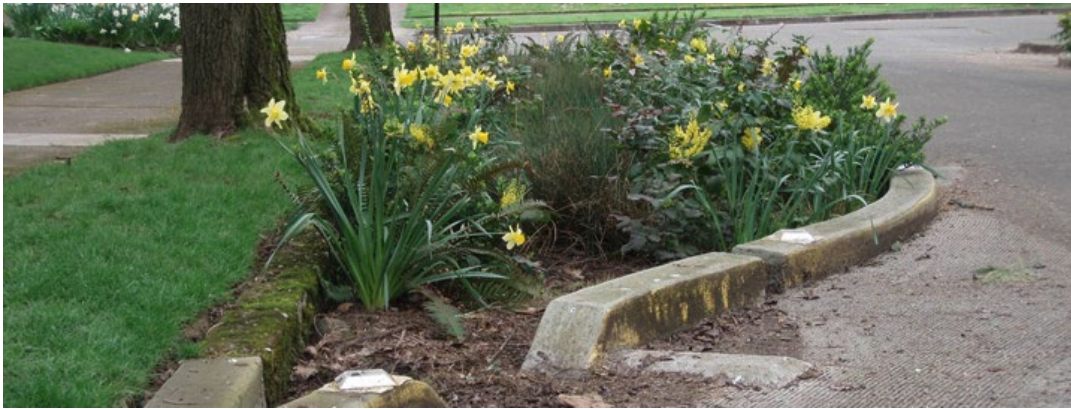
Photo 9.6: Curb bumpout, Source: Phillywatersheds.org
